NATIONAL PROGRAM FOR INSPECTION OF NON-FEDERAL DAMS
SUCKER BROOK DAM (VT. (U) CORPS OF ENGINEERS WALTHAM MA
NEW ENGLAND DIV FEB 80

SUCKER BROOK DAM

VT 00212

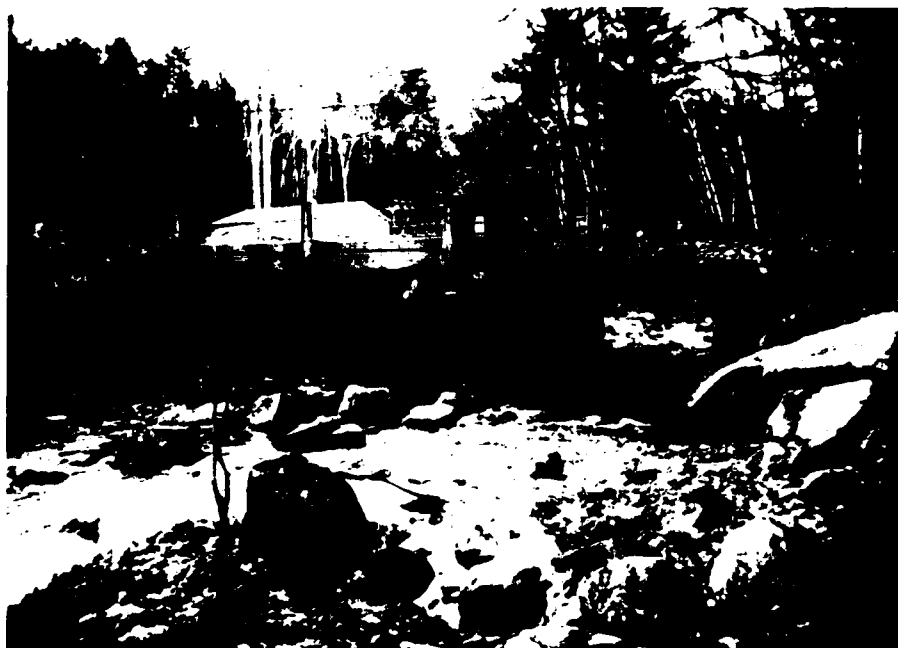
C-12B Vermont State Route No. 53 bridge over Sucker Brook near Lake Dunmore. Note top of powerhouse for Silver Lake Hydro-electric Development visible over left end of bridge - 11/08/79
